Manhole Inspection Summary

Manhole # S43E__079MH

Insp Date: **6/10/08 9:22 AM**

Location Address: **1622 e lombard st**

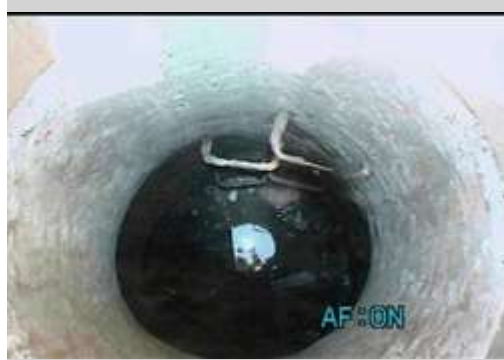
Top View

top view

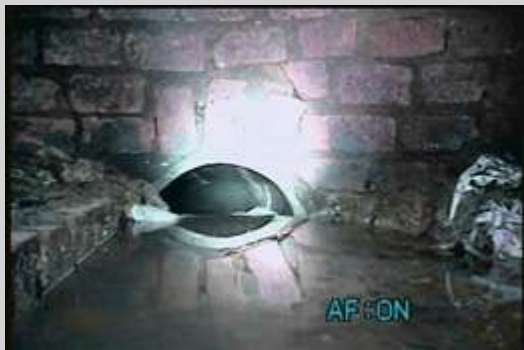
12 O'Clock Outflow

8 in. Circular Gravity Sewer
Pipe Out @ 12 OClock

Pipe Height: 0 (in.) Direct
Pipe Material: **Clay** ☐ Pipe Lined
Invert Depth: 11.13 (ft.) Flow Characteristics: **Slow**
Deposits: ☒ None ☐ Mud ☐ Sludge ☐ Debris ☐ Grease
Silt Depth: 0 (in.) Deposits Extent:
Infiltration: **None** Pipe Seal Cond: **Unknown**

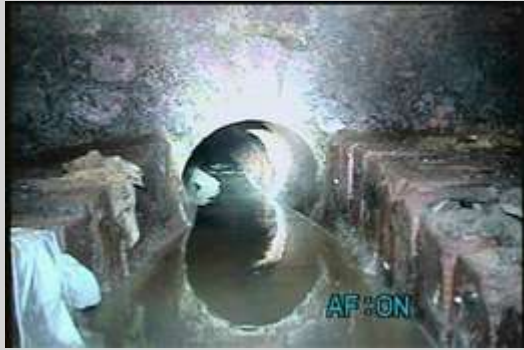
6 O'Clock Inflow

8 in. Circular Gravity Sewer

Pipe In @ 6 O'Clock

Pipe Height: **0** (in.) Direct

Pipe Material: **Clay** ☐ Pipe Lined

Infiltration: **None** Pipe Seal Cond: **Unknown**
